28 December 2022

**Land Filling Activities Spotted in Ha Wo Hang, Sha Tau Kok –
Green Power's Response to Planning Department's Enforcement Action**

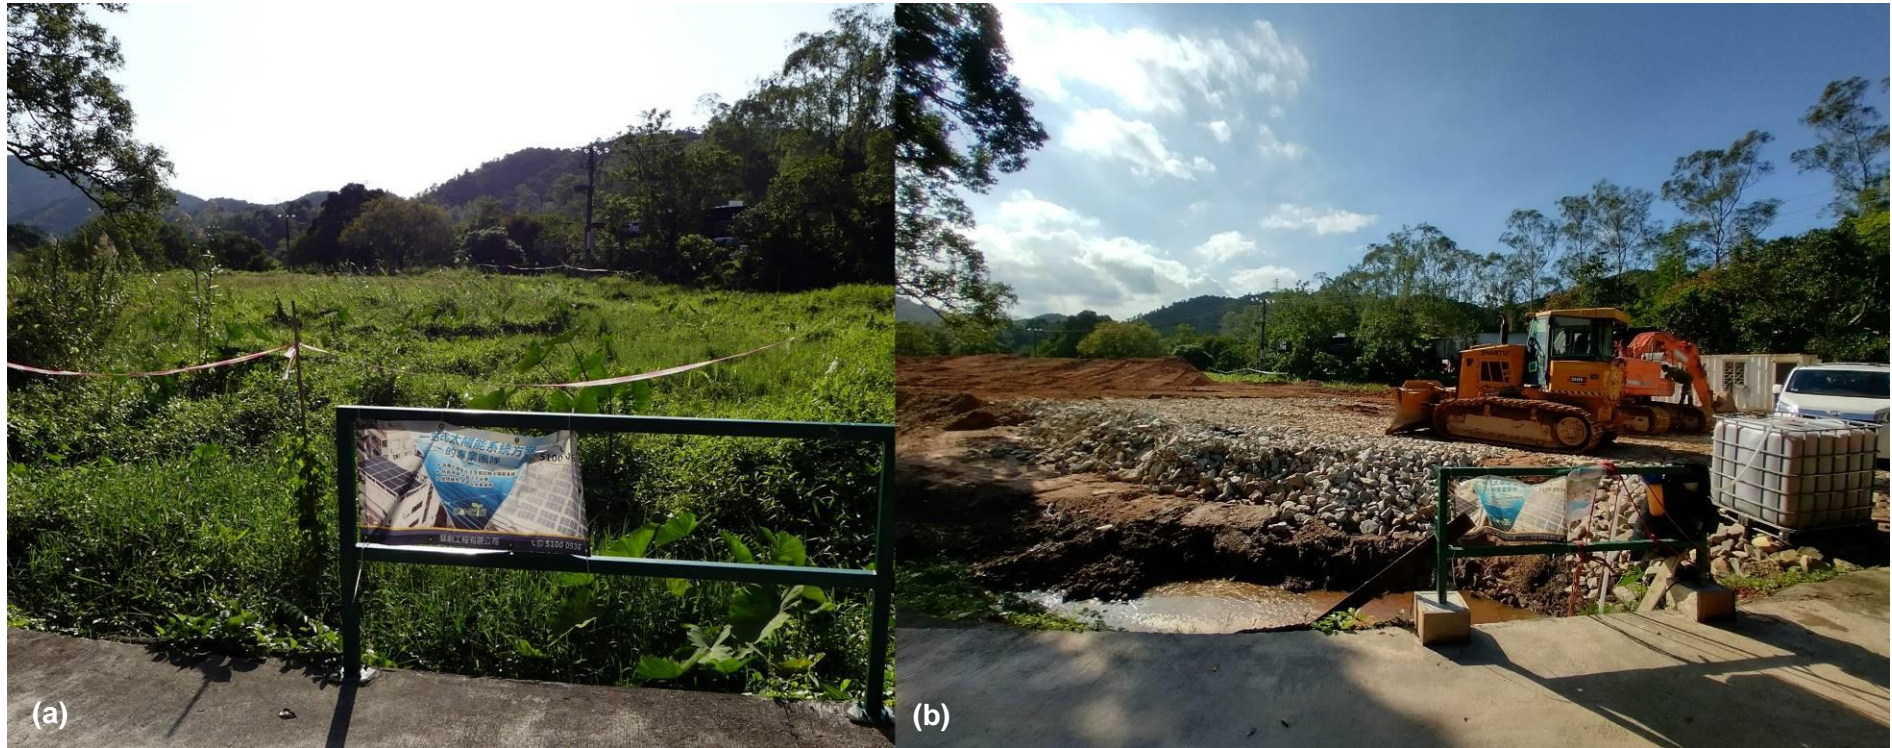
Figure 1. Photos showing (a) wetland vegetation cover in the riparian wetland before the incident and (b) filling of C&D materials and vegetation clearance on the wetland, as well as substrate disturbance and pollution of a nearby stream section. Photo taken in (a) October, 2022 and (b) November 2022

2. As mentioned in our submitted complaint, the natural streams and freshwater wetlands they drain in Ha Wo Hang and the nearby Sheung Wo Hang form an interlinked and valuable ecosystem, and support a rich freshwater fauna that deserves protection. The site is a prominent odonate hotspot where a total of 52 species of odonates (>40% of HK species total) have been recorded within a single wet season. One of the stream sections bordering the impacted site is downstream of an Ecologically Important Stream, and the filled riparian areas were originally well covered by wetland plants such as *Colocasia esculenta*, *Cyclosorus interruptus*, *Hedychium coronarium* and *Phragmites vallatorius*, indicating soil and vegetation characteristics of a wetland (Figures 1-3).

3. The illegal land filling activities spotted in Ha Wo Hang on 29th November, 2022 involved clearing of large areas of vegetation cover, filling of extensive freshwater wetland areas with soil / C&D materials more than 1.2m in thickness, pollution and substrate disturbance along a natural stream section nearby. The typical reinstatement requirement of grassing damaged natural areas regardless of their original habitat types and environmental qualities is inadequate in protecting the environment or high-quality arable land. We opine that reinstating the impacted area to the condition before the incident is crucial for fulfilling the planning intention. That includes removal of all filled materials from the wetland and natural stream section, as well as restoration of previous wetland plant coverage, soil condition and original hydrological and physical conditions of the impacted stream section.

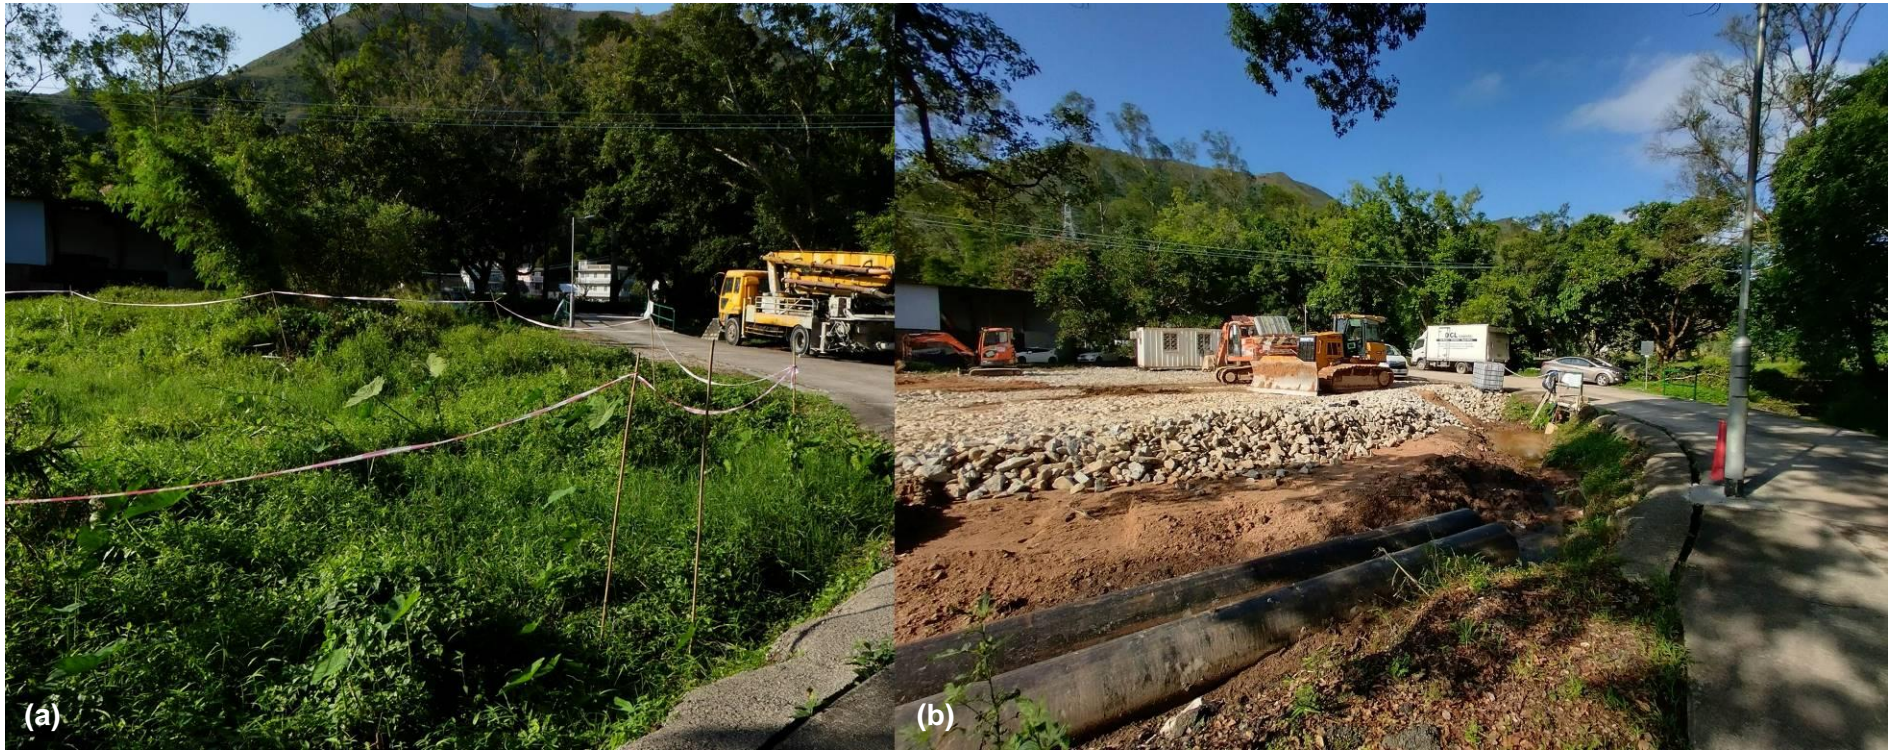
Figure 2. Photos showing (a) wetland vegetation cover in the riparian wetland before the incident and (b) filling of C&D materials and vegetation clearance on the wetland, as well as substrate disturbance, pollution of a nearby stream section. Photo taken in (a) October, 2022 and (b) November 2022

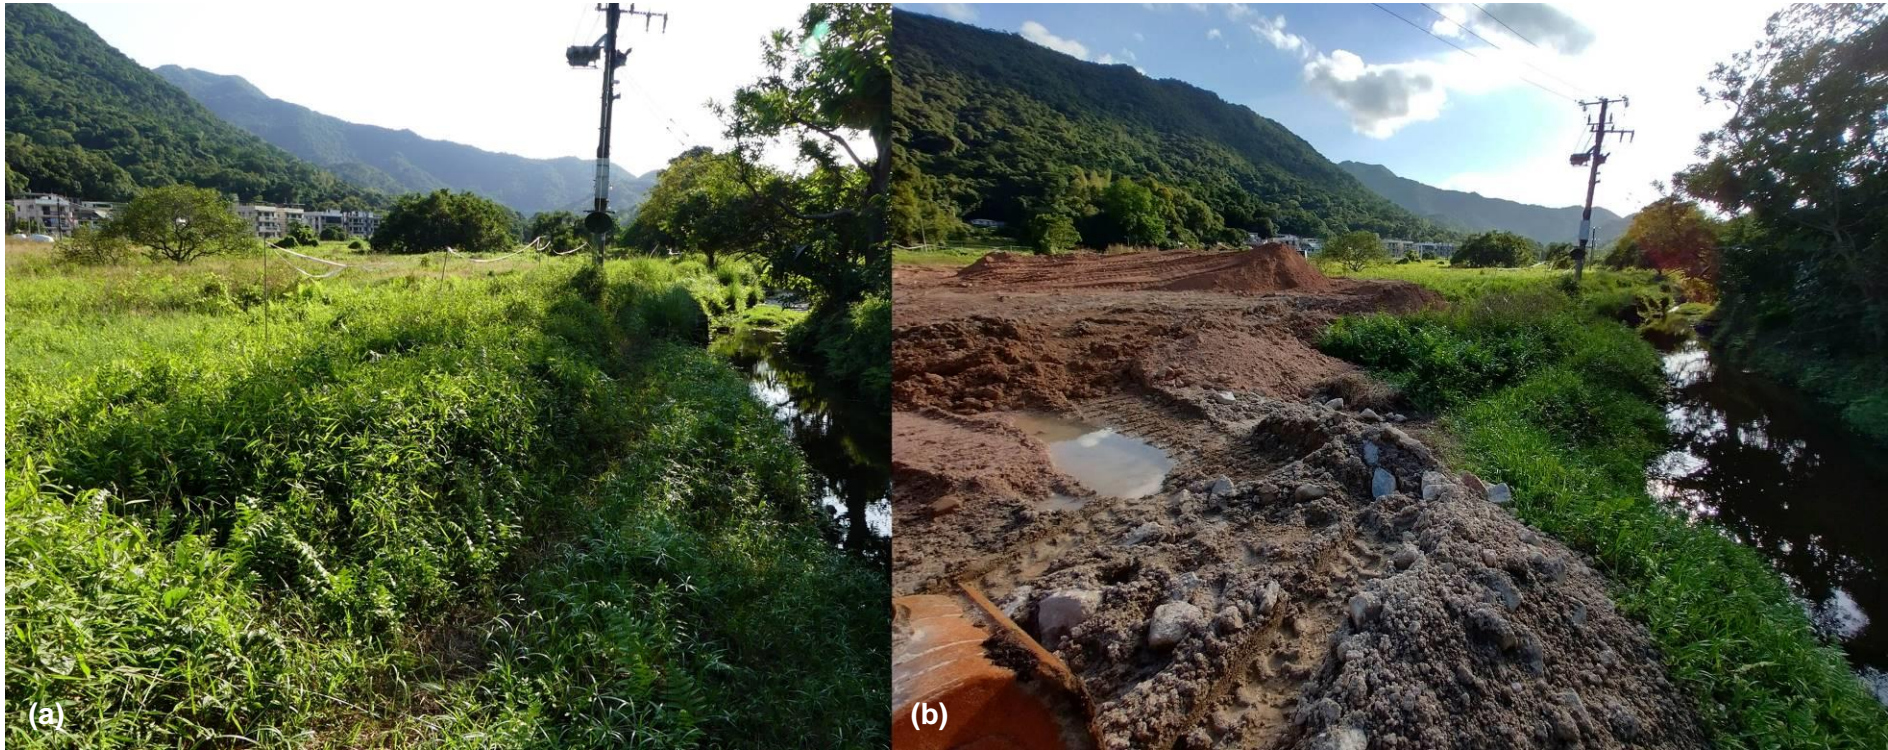
Figure 3. Photos showing (a) wetland vegetation cover in a riparian wetland before the incident and (b) filling of C&D materials and vegetation clearance on the wetland. Photo taken in (a) October, 2022 and (b) November 2022.
